Picture 1 – Ballard Acres, 1900 Ballard Rd., St. Albans, VT – 09/18/14
Silage bunker area, graded for the new leachate/runoff collection system.

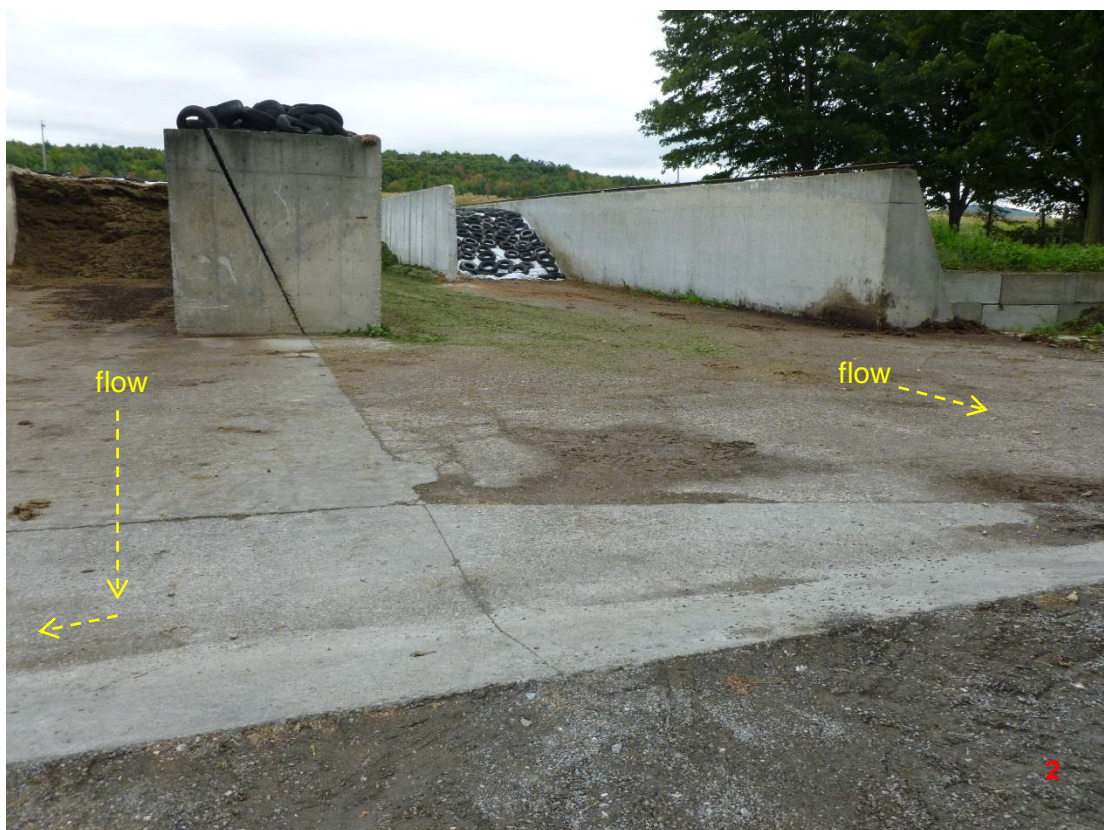
Picture 2 – Ballard Acres, 1900 Ballard Rd., St. Albans, VT – 09/18/14
View of flow direction from the silage bunkers.

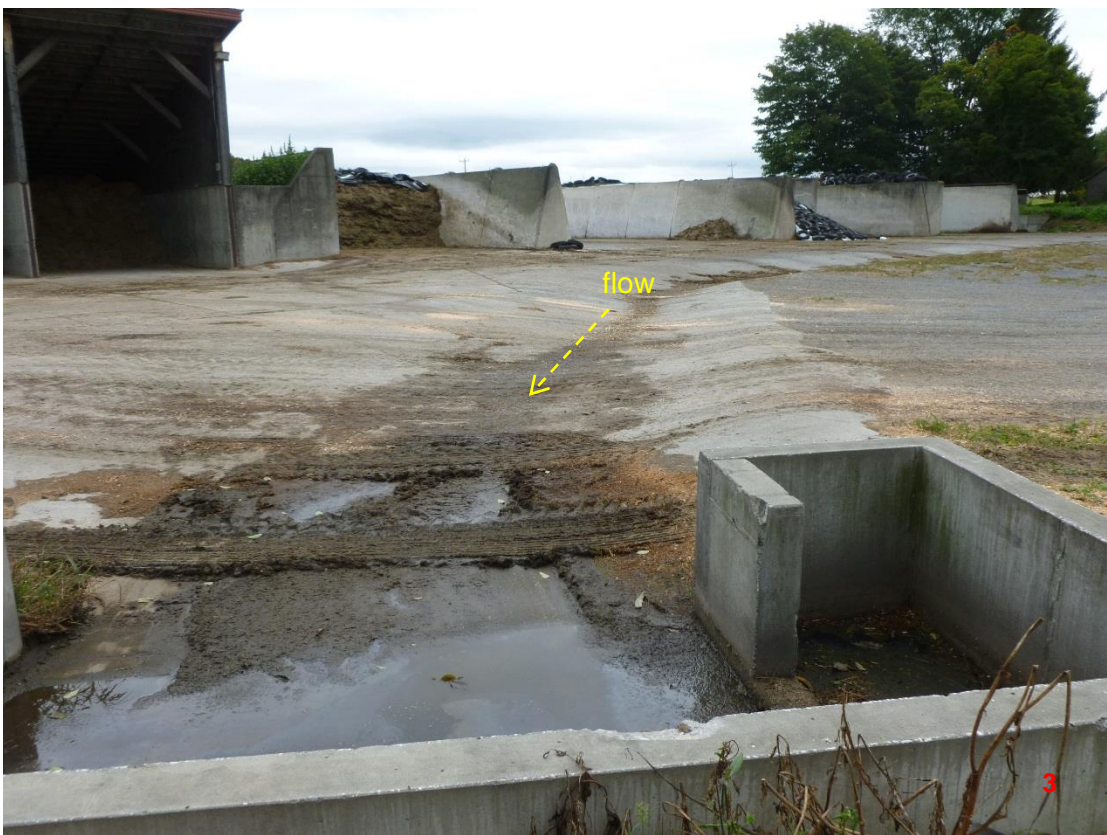
Picture 3 – Ballard Acres, 1900 Ballard Rd., St. Albans, VT – 09/18/14
Collection bay and inlet to the silage leachate system.

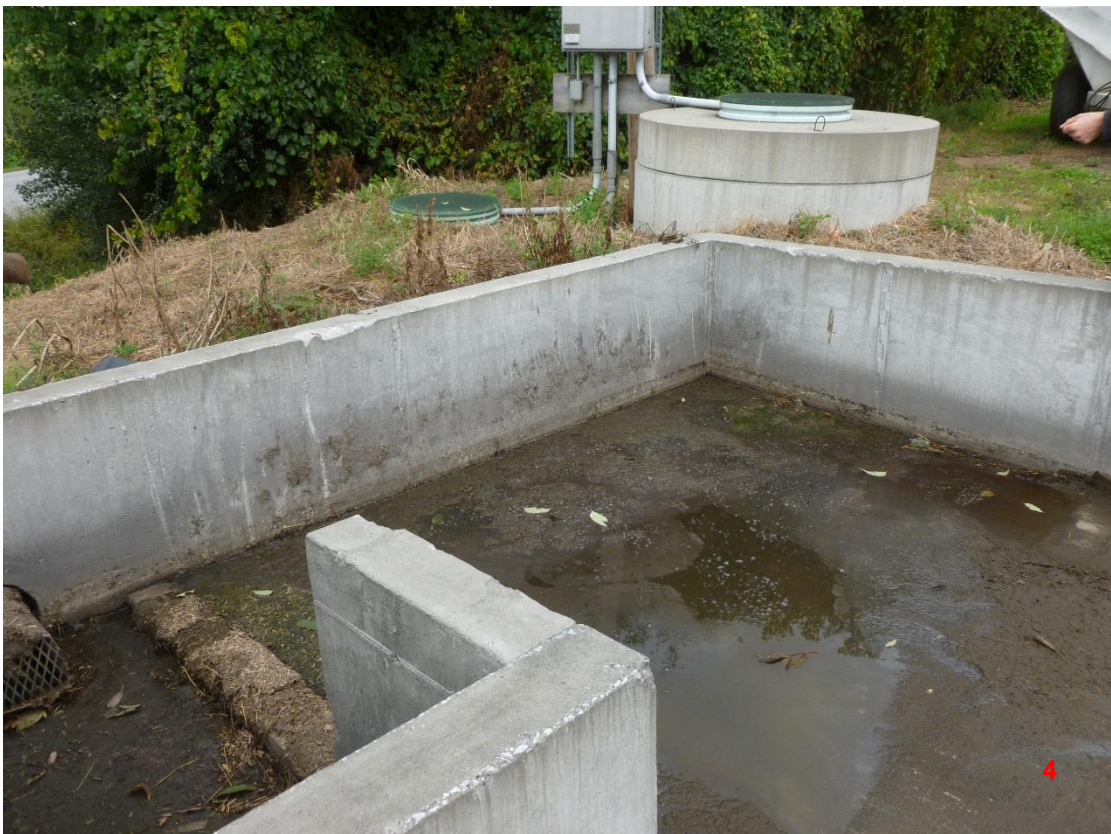
Picture 4 – Ballard Acres, 1900 Ballard Rd., St. Albans, VT – 09/18/14
Collection bay and inlet to the silage leachate system.

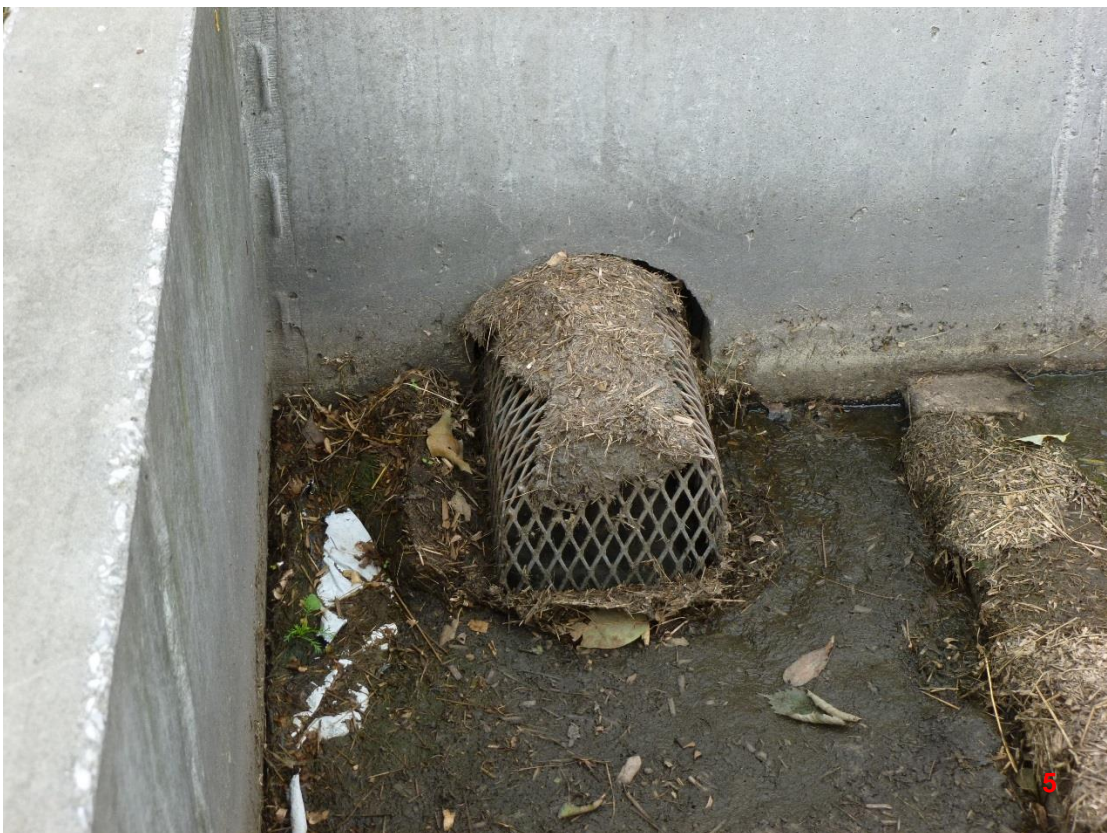
Picture 5 – Ballard Acres, 1900 Ballard Rd., St. Albans, VT – 09/18/14
Inlet to the low-flow collection tank, covered by solids.

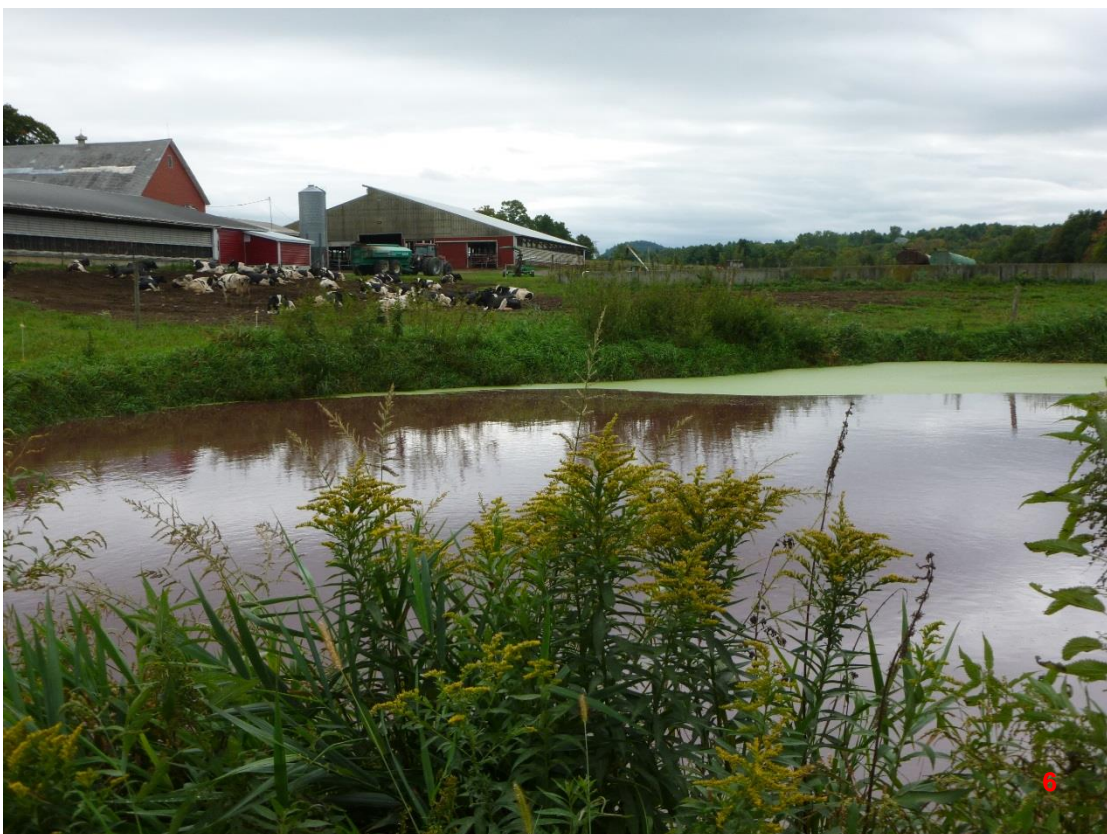
Picture 6 – Ballard Acres, 1900 Ballard Rd., St. Albans, VT – 09/18/14
New detention pond for high-flow leachate/runoff from the silage area.

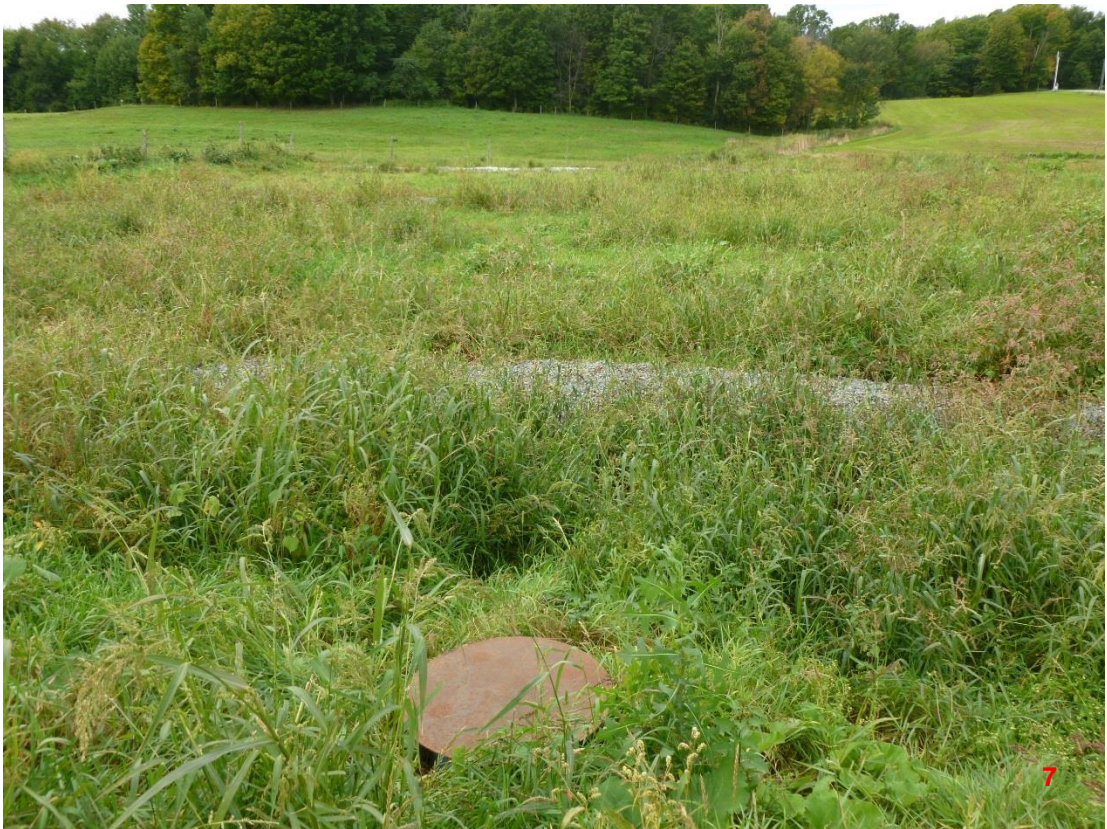
Picture 7 – Ballard Acres, 1900 Ballard Rd., St. Albans, VT – 09/18/14
Vegetated treatment cell for high-flow leachate runoff. (Pipe and valve are in the manhole).

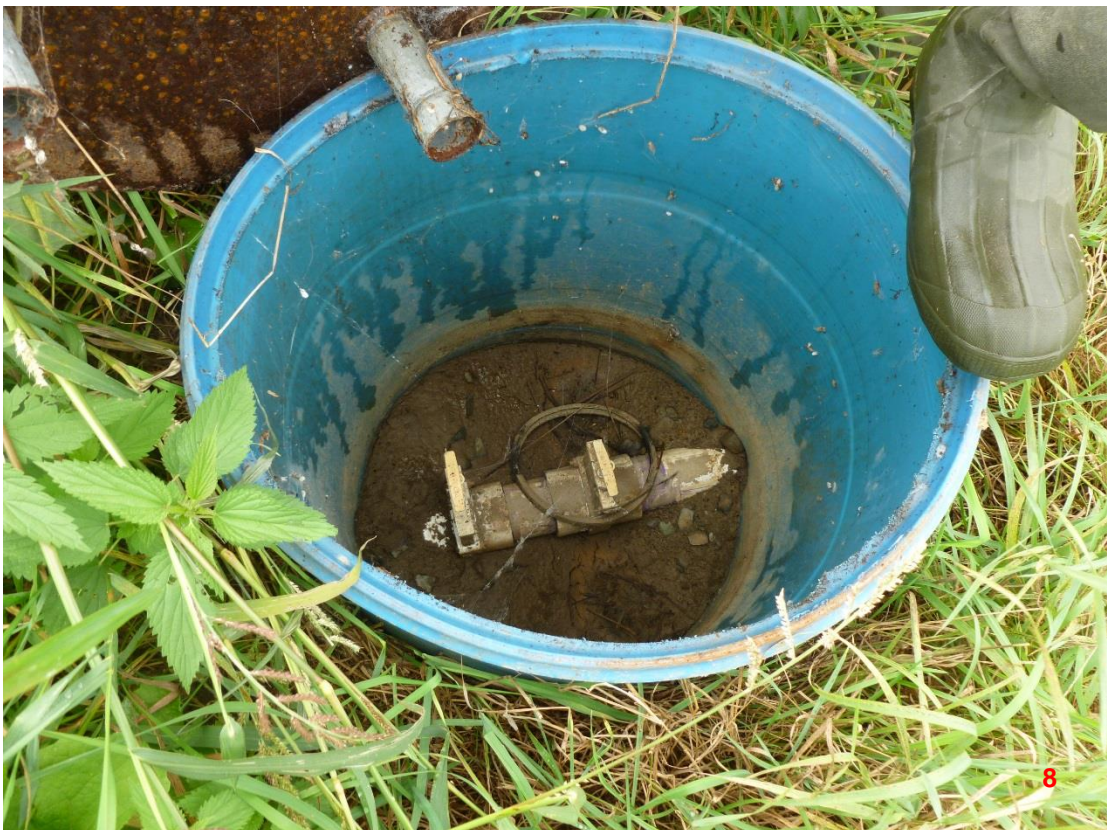
Picture 8 – Ballard Acres, 1900 Ballard Rd., St. Albans, VT – 09/18/14
Manhole pipe and valve connection to the vegetated treatment cell (in picture 7).

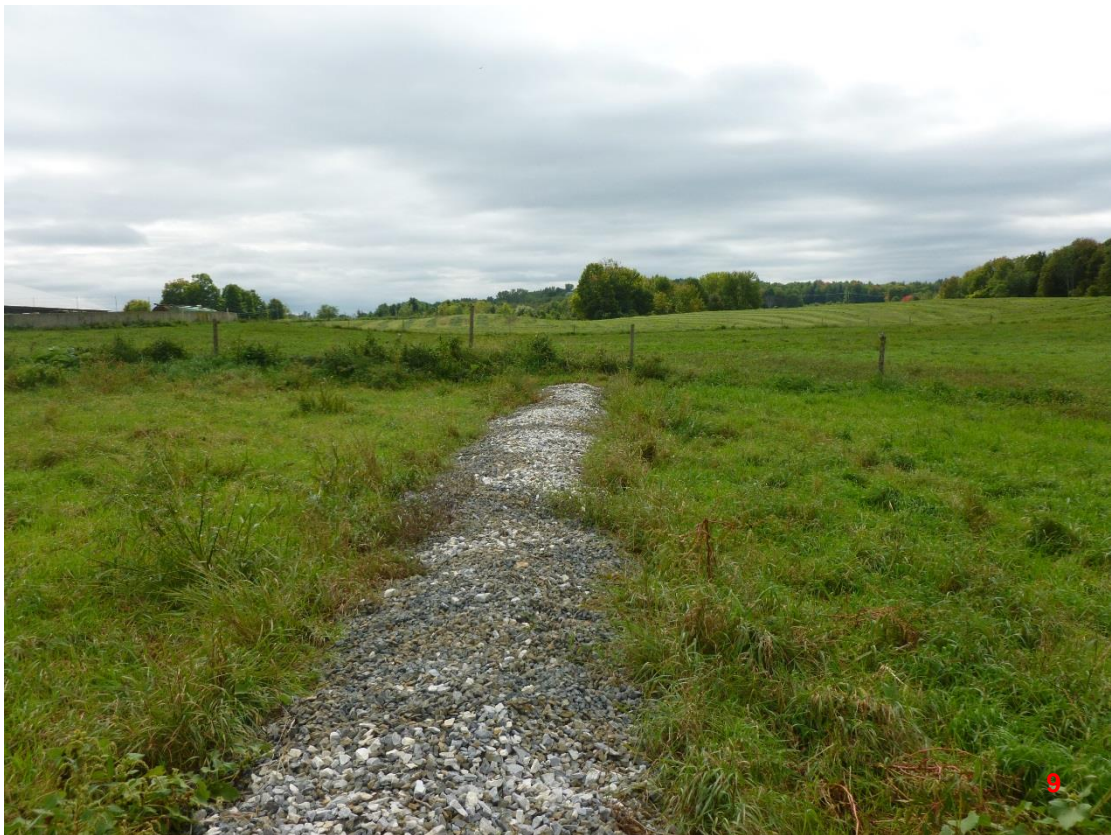
Picture 9 – Ballard Acres, 1900 Ballard Rd., St. Albans, VT – 09/18/14
Gravel layer at the end of the vegetated treatment cell.

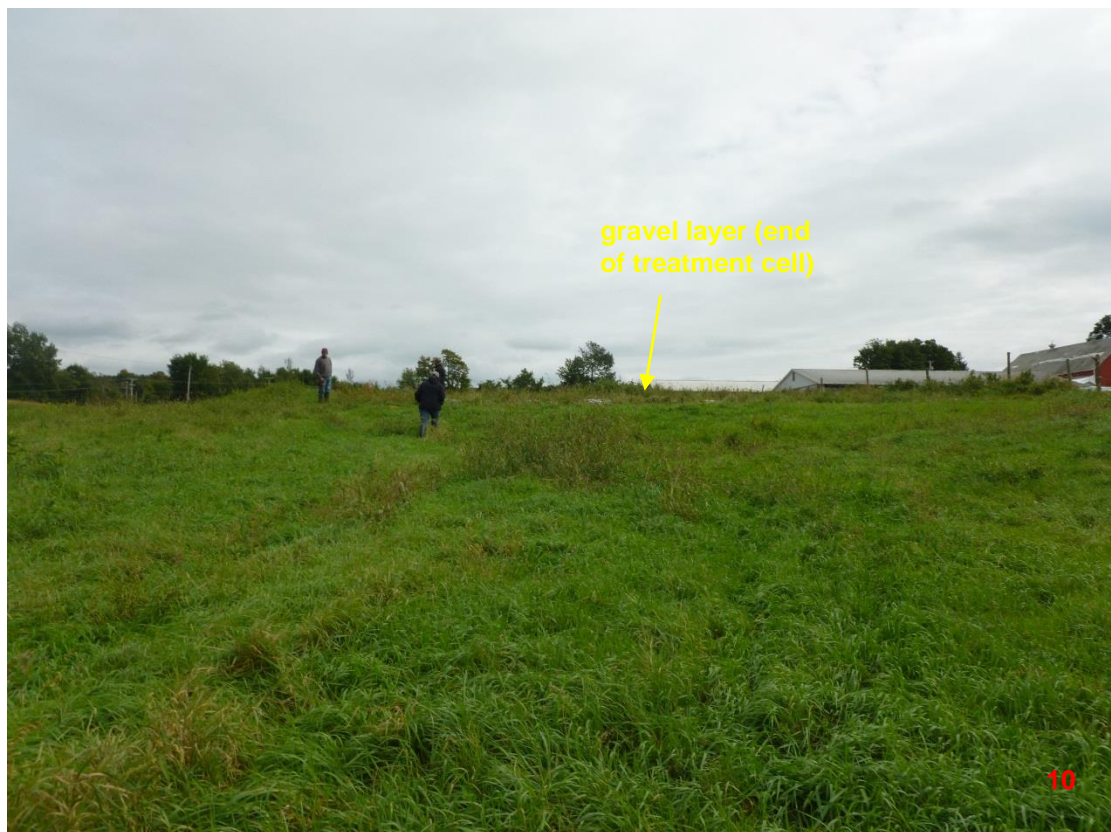
Picture 10 – Ballard Acres, 1900 Ballard Rd., St. Albans, VT – 09/18/14
Grassy pasture area located downgradient of the vegetated treatment cell.

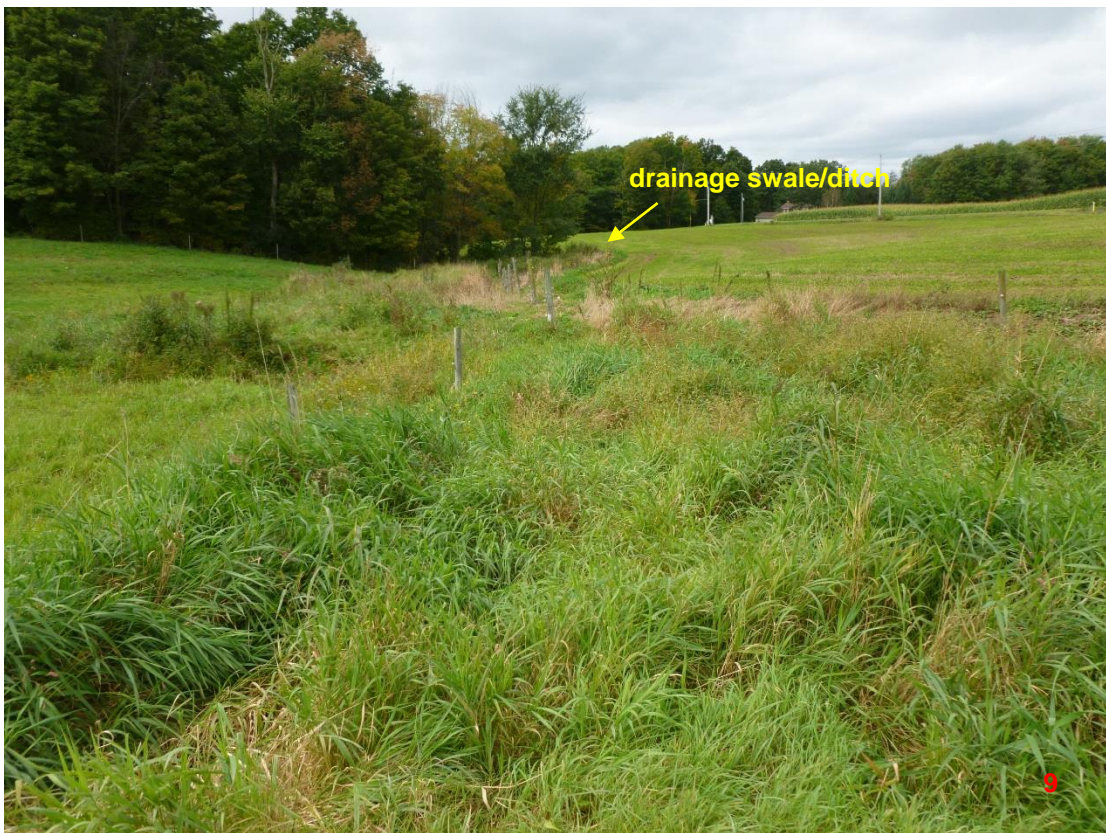
Picture 9 – Ballard Acres, 1900 Ballard Rd., St. Albans, VT – 09/18/14
End of grassy area/pasture area, which borders a drainage swale/ditch.

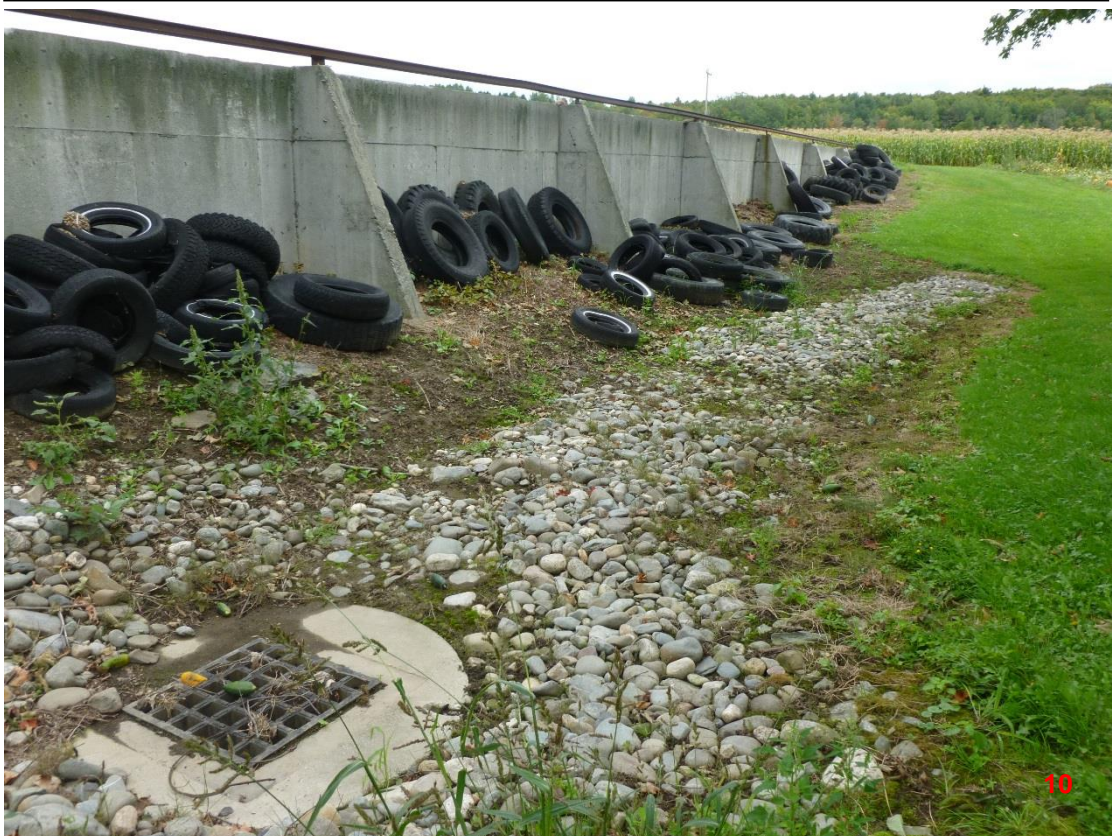
Picture 10 – Ballard Acres, 1900 Ballard Rd., St. Albans, VT – 09/18/14
New drainage system to settle/capture stormwater runoff.
